Evaluation of Volatilization Potential for Legacy Chlordane in Military Housing Area Soils

Scott A. Waisner, Victor F. Medina, Michael A. Jones,
and Catherine C. Nestler

October 2011

Final report

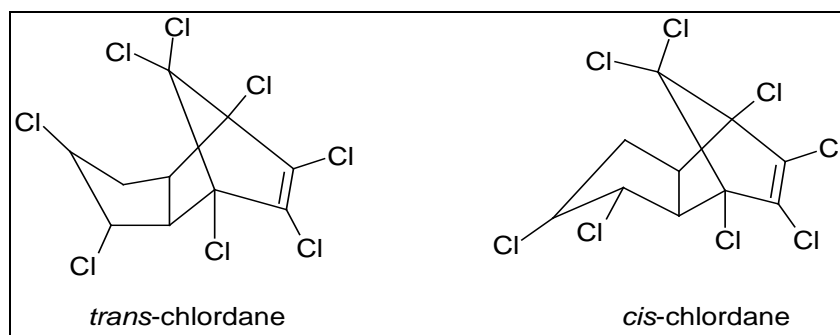
Figure 1. Structural isomers of chlordane.

The *cis*- and *trans*- isomers of chlordane are non-superimposable mirror images (i.e., chiral) and have identical physico-chemical properties. These physical and chemical properties are often difficult to specify for technical grade chlordane because it is a complex mixture (USEPA 1997). For example, the vapor pressure of the mixture will change over time since the more volatile components will be removed faster, changing the composition of the mixture. However, the ratio of chlordane isomers will remain the same since these processes are not selective for a particular isomer. This is true for all the physical processes affecting chlordane such as volatilization, hydrolysis, or photodegradation (Müller et al. 1997).

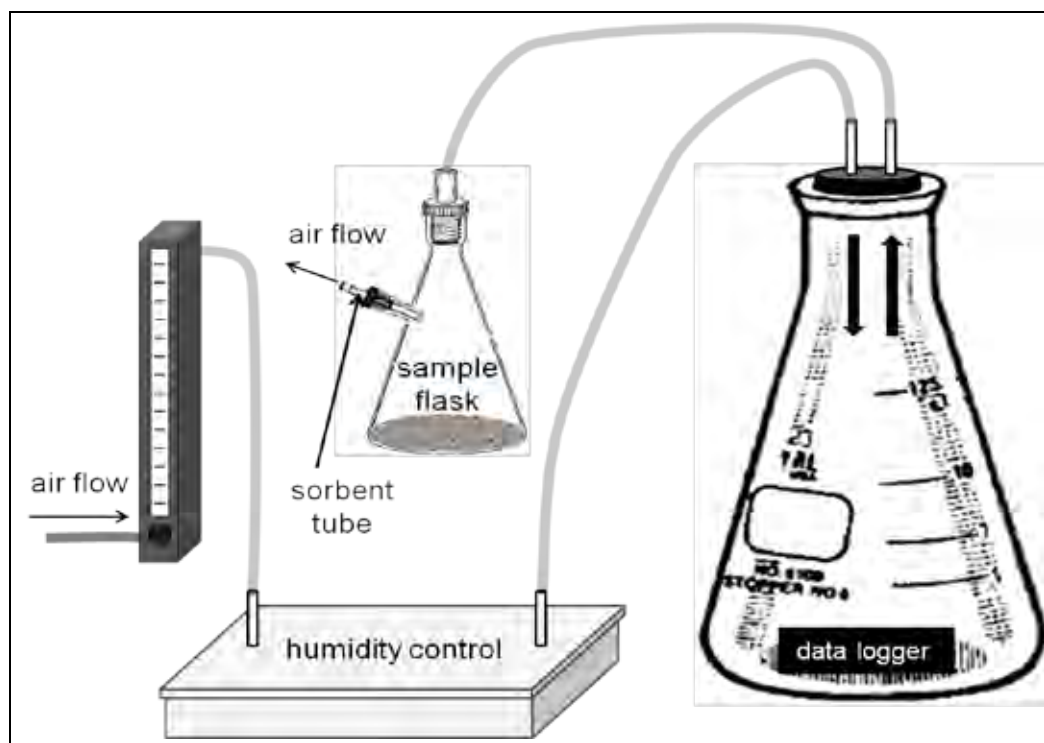
Figure 2. Schematic of bench-scale setup.

This test was conducted by adding 50 g of soil to 250-mL single-side-arm shake flasks (Ace Glass #14205). The bottom diameter of the flask was 7.62 cm (3.00 in.), which provided a soil surface area of 45.6 cm². One flask containing only 25 mL of the 3:1 chlordane:water emulsification was also set up as a control to measure volatilization rates unhindered by the desorption process. The solution in this flask covered an area in the bottom of the flask approximately 6.35 cm (2.5 in.) in diameter, which provided a surface area of 31.7 cm².

Air flowed into the flask through the neck at a rate of 50 standard cubic centimeters per minute (sccm) and exited through Chromosorb-102 sorbent tubes fitted into the side arm. A schematic of the experimental apparatus is shown in Figure 2. The temperature and humidity of the flask were controlled according to the experimental matrix (Table 2).

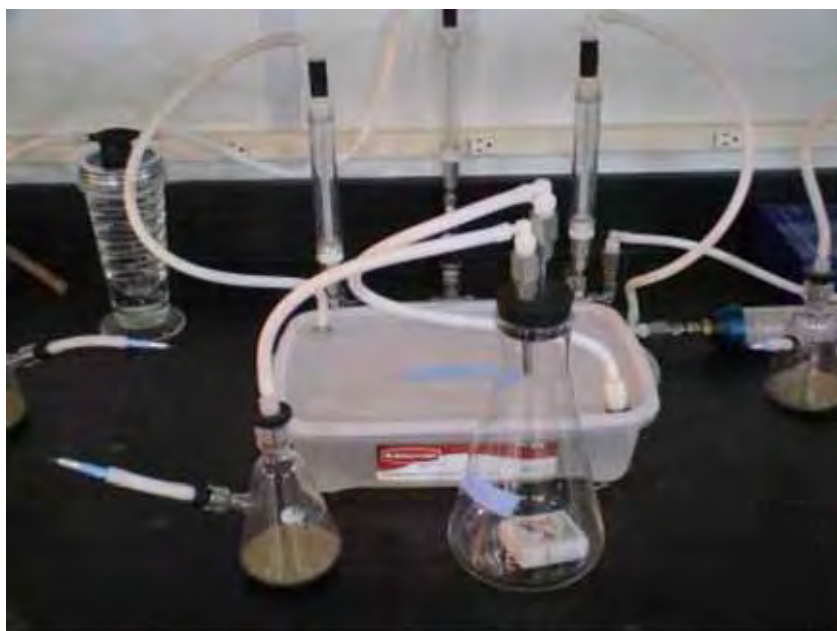
Figure 3. Bench-scale setup.

Three different levels of relative humidity (RH) were established using three different control techniques placed in the flow path prior to the flasks. Drierite desiccant material in a column was used to give a low RH of about 10%. A medium level RH of approximately 50% was achieved by using a saturated salt solution of NH_4NO_3 in a plastic container. A high level RH of 90-100% was achieved by sparging air through deionized water (Figure 3).

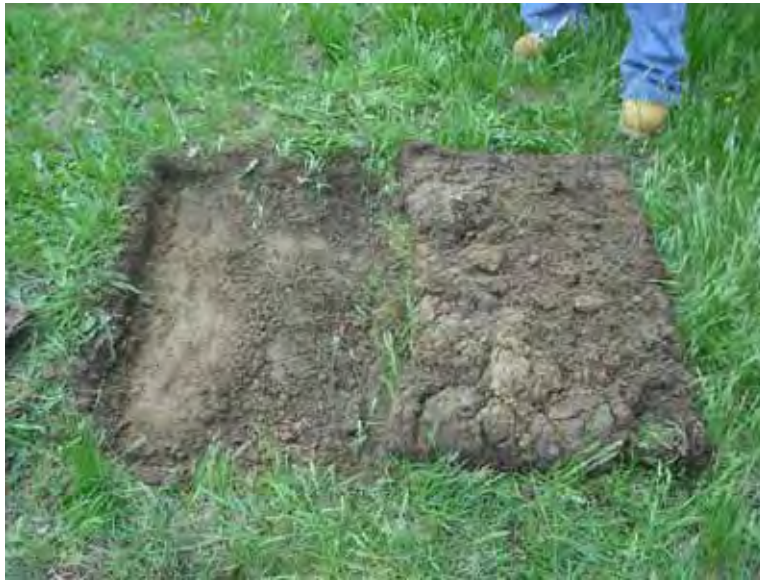
Figure 4. Surface disturbance.

Surface disturbance of the tested soil was achieved by removing a grass layer approximately 1 m² in size. The soil was turned so the roots were facing upwards (Figure 4). Shallow disturbance was achieved by using the same technique, and the soil was tilled to a depth of 16 in. (Figure 5). The soil was tilled in flights with a rotary garden tiller and the soil was removed between flights. After reaching a depth of 16 in., the soil was replaced in the excavated hole.

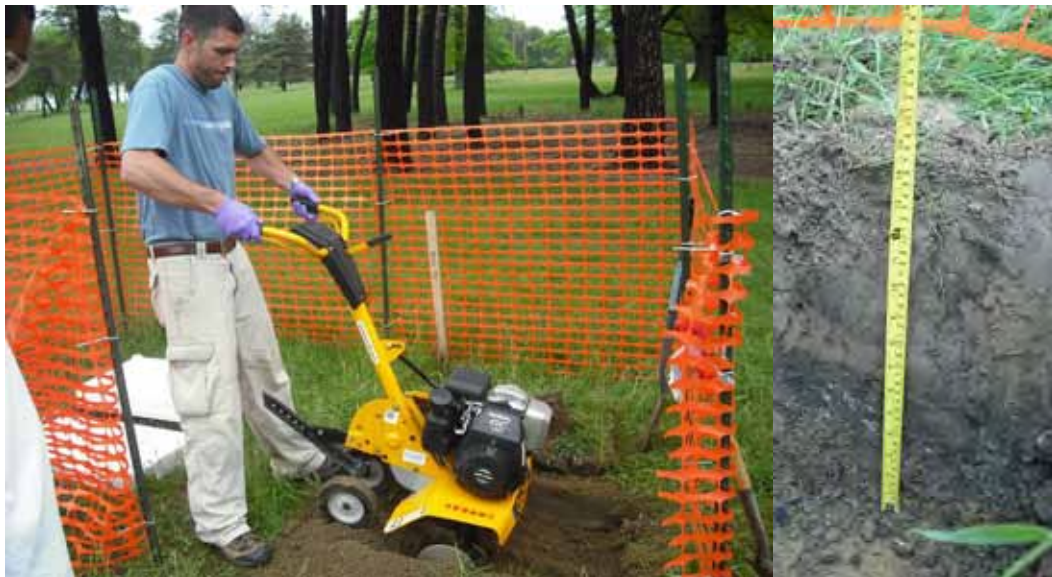
Figure 5. Using tiller to create shallow disturbance.

Both air samples and soil samples were collected for chlordane analysis from four different types of soil disturbances to estimate potential release and exposure to volatile chlordane from the soil during future construction activities. Three different soil-disturbance scenarios were conducted at the test location to mimic normal unconfined disturbance of surface soils during construction: a scraped (denuded) soil surface, a grass root-zone, and a denuded soil tilled to a 16-in. depth. In addition, a 2-ft deep hole was bored to estimate the potential for exposure to volatilized chlordane in a shallow trench excavation. The soil core was also analyzed to establish a depth profile of chlordane contamination in the soil. An air sample from undisturbed surface soil was also collected as a control in the same manner as the shallow disturbance samples.

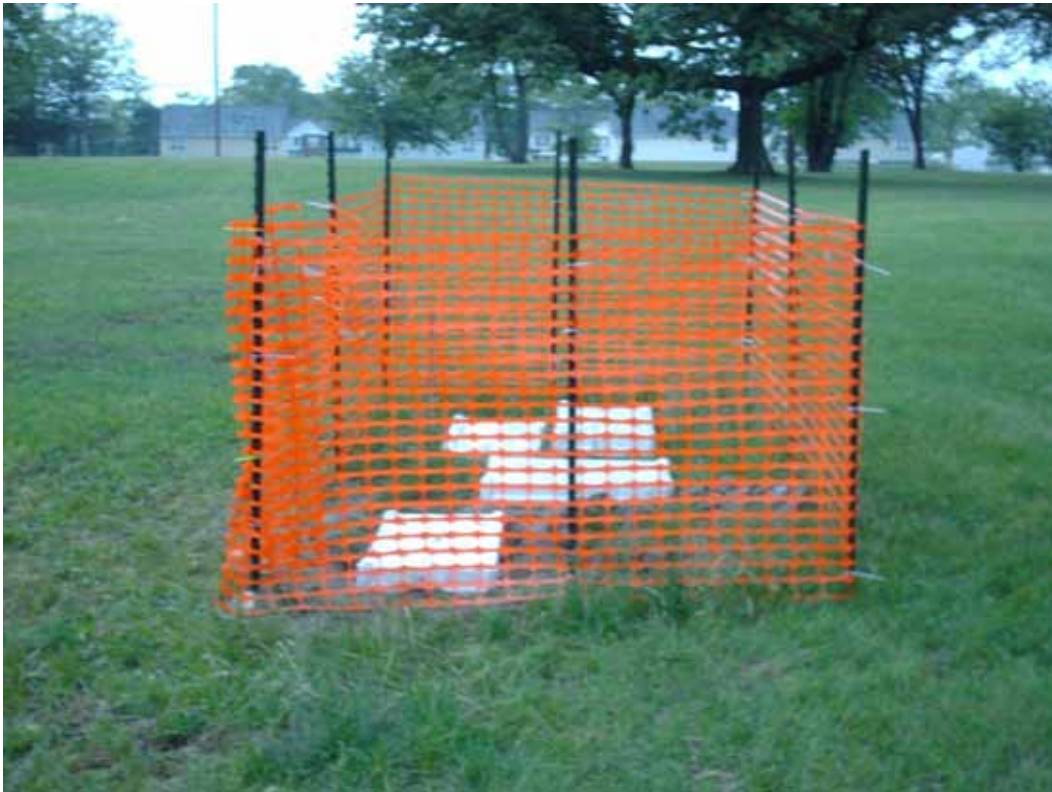
Figure 6. Test site.

Air samples from surface and shallow disturbance were collected by placing large fiberglass trays, used as flux chambers, over the areas both during and between sampling events. Flux chambers were placed over root-zone and the freshly exposed soil areas to prevent loss of contaminant due to dispersion and advection by the wind (Figure 6). Sorbent tubes were connected to the flux chambers and sampling pump by PVC tubing. The sample train is shown in Figure 7.

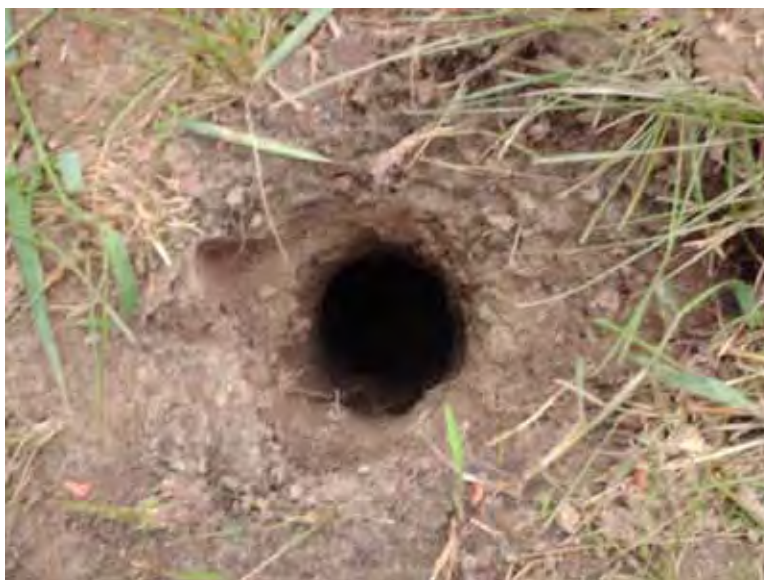
Figure 8. Borehole.

A 2-ft-deep borehole in the soil was created (Figure 8) with a 2-in.-diameter hand coring device to obtain the core samples. The original goal was to achieve a 36-in.-deep hole; however, refusal was reached at approximately 24 in. below-ground-surface (bgs) depth due to concrete

debris encountered at that depth. Samples were removed from the cores to give a depth profile of pesticide concentrations at 2 to 8, 8 to 16, and 16 to 24 inches bgs. Each section of the core for the corresponding depths was homogenized by hand in the laboratory and sampled for analysis. Air sampling from the borehole was accomplished by placing the sorbent tube near the bottom of the borehole. The sorbent tube was attached to PVC tubing, which was connected to the sample pump at the surface. To simulate the conditions of an open trench on a construction site, the borehole was not capped at any time.

Collection of gas samples provided only one positive result. This sample was collected from the bottom of the bore hole immediately after excavation and was determined to be 11.7- $\mu\text{g}/\text{m}^3$, which is far below the recommended time weighted average (TWA) exposure limit of 0.5-mg/ m^3 for workers exposed to chlordane. The sample collected from the same location the next day

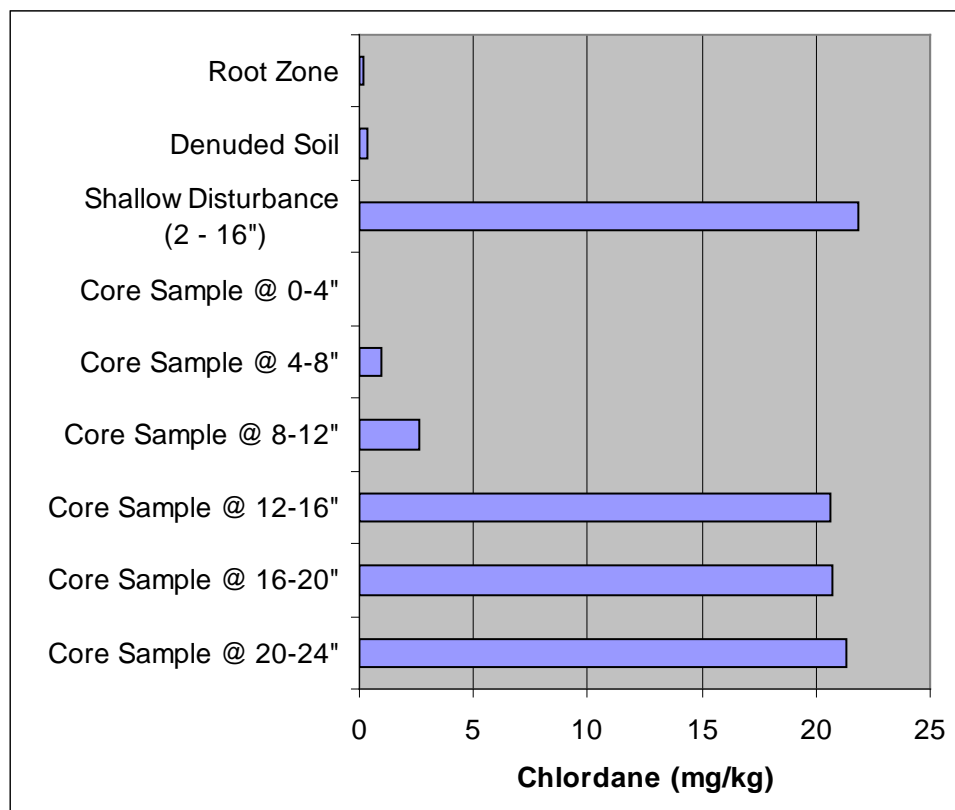
Figure 9. Ft. Dix soil chlordane profile.

Sample (Ft. Dix Soils)	Mean (mg/Kg)	Std Dev.
Root-zone	0.14	0.10
Denuded soil	0.38	0.42
Shallow disturbance	21.87	12.87
Core Sample @ 0-4"	0.09	NA
Core Sample @ 4-8"	0.92	NA
Core Sample @ 8-12"	2.63	NA
Core Sample @ 12-16"	20.60	NA
Core Sample @ 16-20"	20.70	NA
Core Sample @ 20-24"	21.3	NA

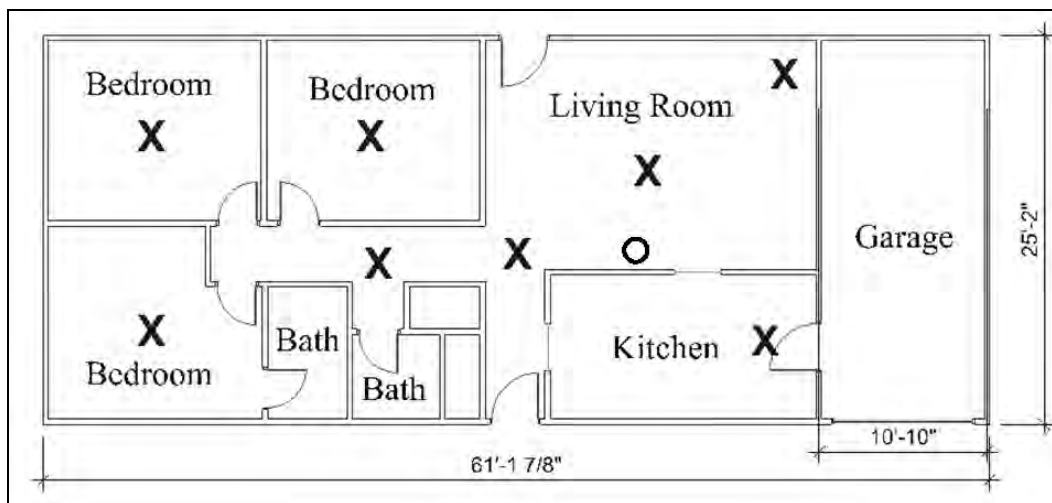
Figure 11. Floor plan for 4433B Sijan Street. Sub-slab testing locations are indicated by an "X," and indoor vapor sample location is indicated by an "O."

The duplexes were located at 4432B (N43° 3'10" W115°51'2") and 4433B (N43° 3'10" W115°51'6") Sijan Street in the Gunfighter Manor subdivision (Appendix C). Unit 4432B is shown in Figure 10. Each duplex unit had a foundation footprint of approximately 1500 ft², and the floor plans were identical for the two units tested. The floor plan is depicted in Figure 11 with the indoor air and sub-slab sample locations indicated. There were eight sub-slab sample locations and one indoor air sample location in each of the duplex units tested.

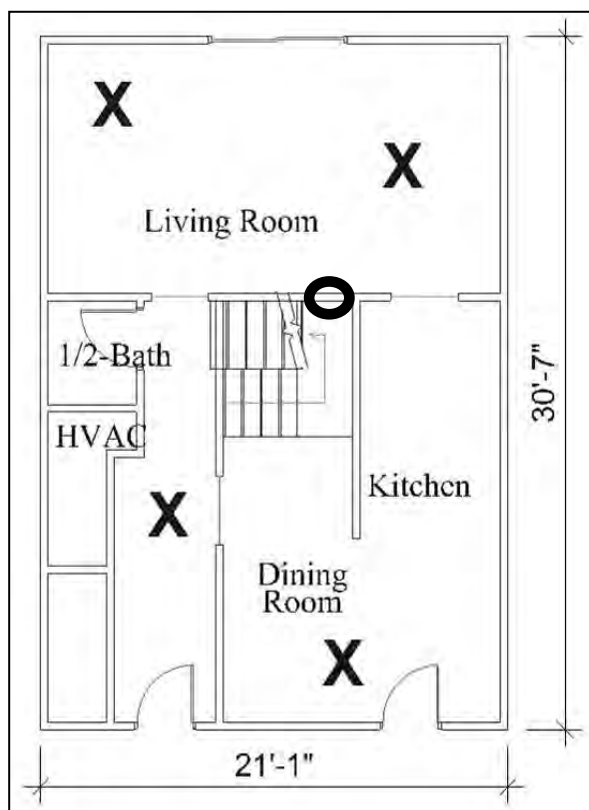
Figure 13. Floor plan for 4816E Mellen Dr. Sub-slab testing locations are indicated by an "X," and indoor vapor sample location is indicated by an "O."

The remaining units chosen for sampling were multi-unit dwellings in the Dunes subdivision located on Mellen Drive, now named Chestnut Street (Appendix C). Units 4816 E and F (N43° 3'46" W115°51'7") were two adjacent units in an 8-unit building, which is shown in Figure 12. Each two-story unit had a foundation footprint of approximately 600 ft², and the floor plans for units E and F are mirror images of each other. The floor plan for unit E is depicted in Figure 13 with the sub-slab and indoor-air sample locations indicated. Because of the small foundation footprint of these units, four sub-slab sample locations were used in each of the adjacent units, and one indoor air sample was collected from unit E.

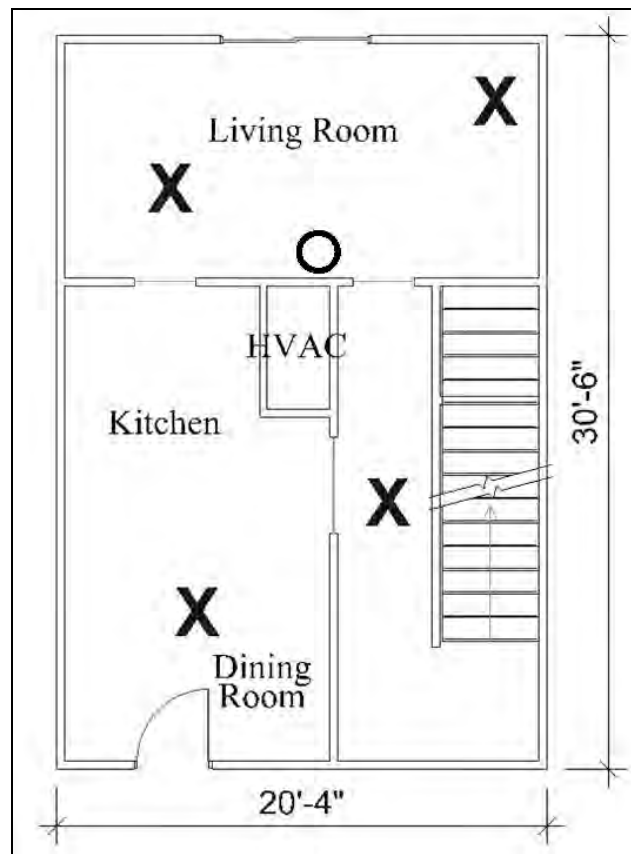
Figure 15. Floor plan for 4818M Mellen Drive. Sub-slab testing locations are indicated by an "X," and indoor vapor sample location is indicated by an "O."

Units 4818L and M (N43° 3'43" W115°51'5") were two adjacent units in a 12-unit building, and are shown in Figure 14. Each two-story unit had a foundation footprint of approximately 600 ft², and the floor plans for units L and M are mirror images of each other. The floor plan for unit M is depicted in Figure 15 with the sub-slab and indoor-air sample locations indicated. Because of the small foundation footprint of these units, four sub-slab sample locations were used in each of the adjacent units, and one indoor air sample was collected from unit M.

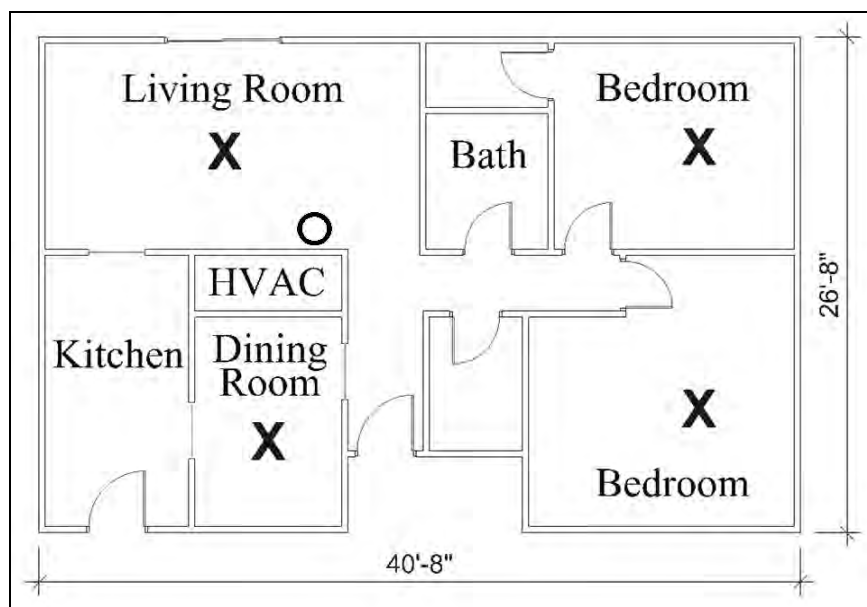
Figure 17. Floor plan for 4824D Mellen Drive. Sub-slab testing locations are indicated by an "X," and indoor vapor sample location is indicated by an "O."

Units 4824 D and E (N43° 3'44" W115°51'2") were part of a 6-unit building located in the Dunes and are shown in Figure 16. Each single-story unit had a foundation footprint of approximately 1080 ft², and the floor plans for units D and E are mirror images of each other. The floor plan for unit D is depicted in Figure 17 with the sub-slab and indoor-air sample locations indicated. Four sub-slab sample locations were used in each of the adjacent units, and one indoor air sample was collected from unit E.

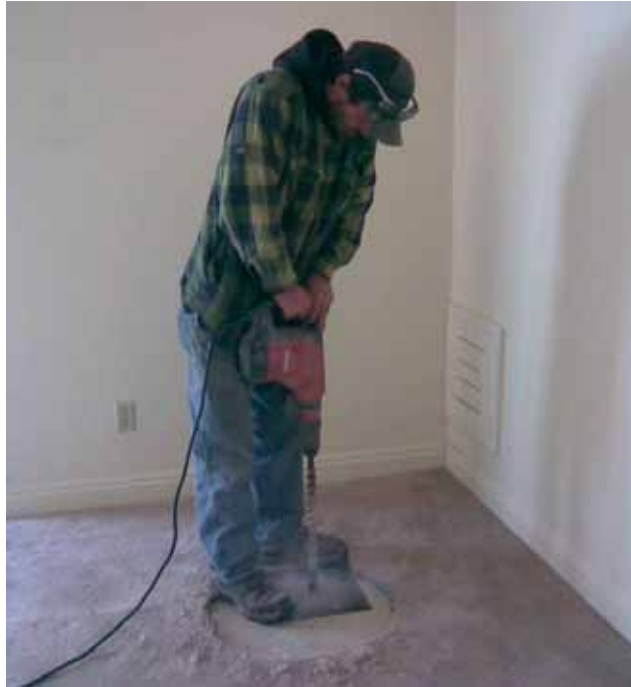
Figure 18. Drilling 1-in. holes.

Sub-slab air sampling. Peninsula Sawing & Drilling (208-587-9071) of Mountain Home, Idaho was contracted to drill 1-in. holes through the foundation slabs (Figure 18). Prior to drilling or cutting, floor covering such as carpet, tiles, and parquet flooring was removed.

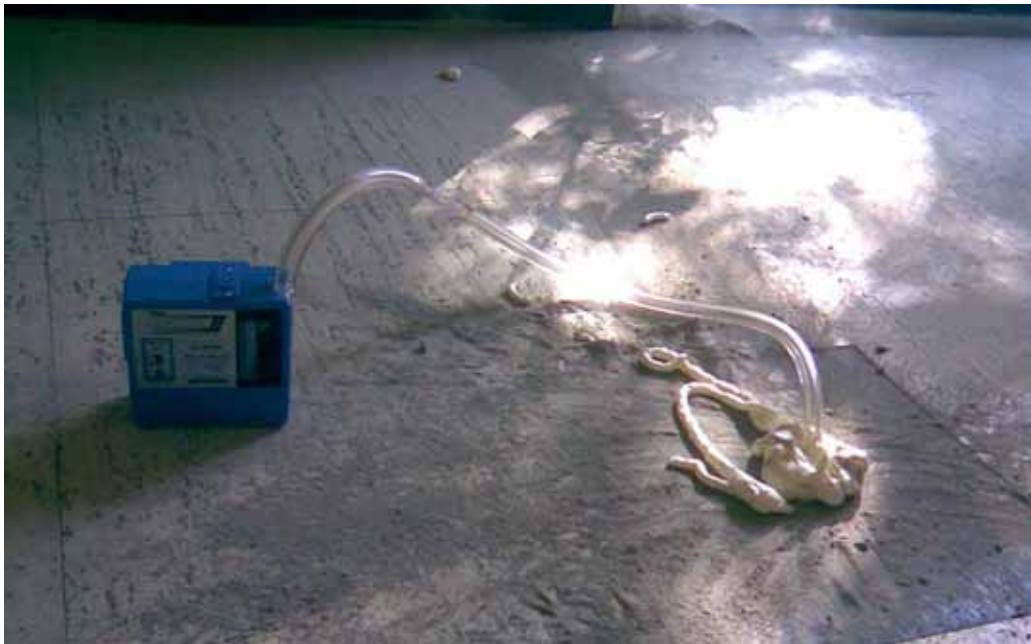
Figure 19. Sub-slab air sampling.

The sorbent tube was then connected to the tubing and an air sampling pump (Figure 19). Samples were collected by drawing the air through a sorbent tube at a constant flow rate of 1 L/min for a period of 4 hr.

Sub-slab air samples were taken from each of the eight separate units. In order to increase the likelihood of a positive result, an attempt was made to distribute the sample locations over the footprint of the tested units. Access to the sub-slab was created by drilling 1-in.-diam holes through the foundation slab at each sample location. A section of 5/8-in. PVC tubing was placed into each hole, and an airtight seal between the tube and the wall of the drilled hole was formed with expanding polyurethane foam.

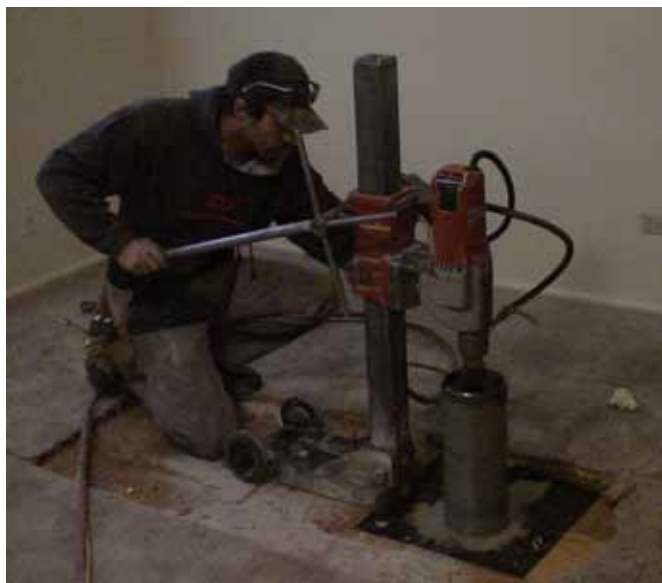
Figure 20. Cutting 6-in. holes.

Following completion of air sampling in each unit, 6-in. diameter holes were cut through the foundation by Peninsula Sawing & Drilling at the same sample locations where the 1-in. holes were previously drilled (Figure 20). After the 6-in. concrete core was removed from each hole, the remaining gravel was removed by hand to access the underlying soil. The depth of gravel under the slabs ranged from 3 to 6 in. and consisted of river rock and pea gravel. A 12-in.-long soil core was collected into 2- butyrate plastic liners using a hand coring device. After coring was complete, the tubes of soil were capped and labeled for shipment back to ERDC.

All drilling and cutting proceeded without incident, except in unit 4432B Sijan Street. The 6-in. hole cut into the corner of the living room penetrated the underground HVAC duct. A second hole was cut and again encountered a ventilation duct. The third hole that was cut missed the duct and was used to collect the soil sample.
